CARDONE ProTech

GM "W" Body Calipers Seized

Application: G.M. "W" body vehicles

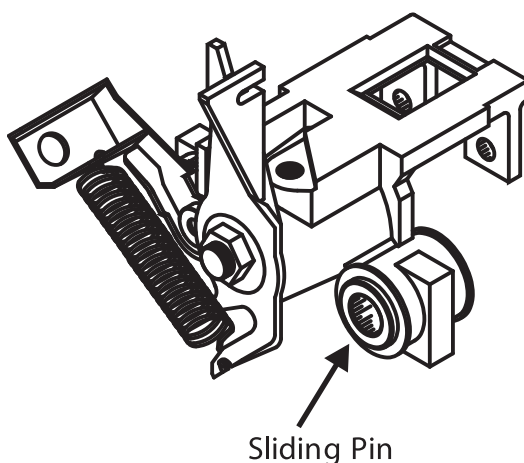
Problem: Corrosion causing the slider pin to seize in the caliper.

Cause: The use of dissimilar metals in the original design results in corrosion in the caliper slider pin bore, causing the slider pin to seize.

Solution: CARDONE caliper part numbers 18-4295, 18-4296, 18-4327 and 18-4328 have a redesigned slider pin and a new dust boot. The redesigned pin allows more high temperature synthetic lubricant to be retained in the slider pin bore, preventing the pin from seizing.
