# CARDONE ProTech

## Ford Power Steering Noise Caused by Pulley Position

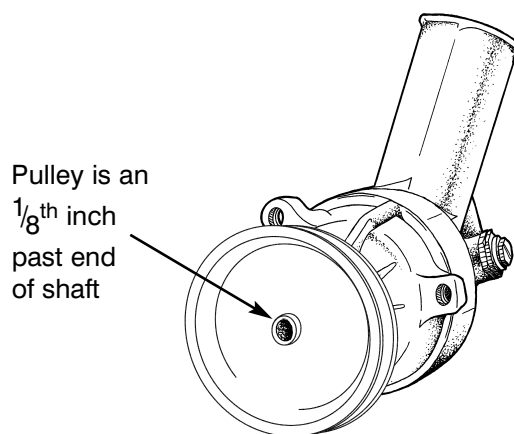
The belt pulley may not be pressed on the shaft in the proper position. Side loading from the misaligned pulley forces internal parts to rub, causing noisy operation.

Make sure the pulley is pressed on  $\frac{1}{8}$ <sup>th</sup> inch past the end of the shaft as shown below. Proper pulley alignment is critical for all applications. Always replace bent or damaged pulleys.
