CARDONE ProTech

Failure To Transfer Sensor Components Results In Shaft Seal Failure Or Check Engine Light

1992-2004 Mazda and Mitsubishi vehicles with sensor-equipped power steering pumps.

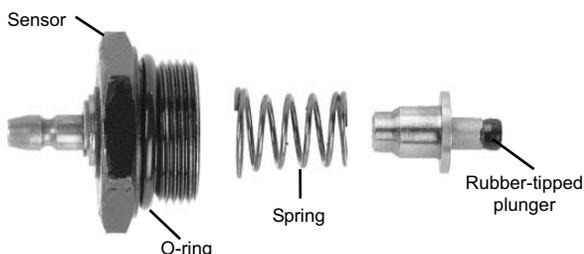
Figure 1. Pressure Sensor Assembly (Rubber-tipped plunger)

It may be necessary to transfer the original sensor and its components (shown below) to the replacement pump. If these components are not transferred correctly, shaft seal failure results due to excessive pressure, or if the sensor is defective, code P550 is set.

Figure 1 shows the sensor, spring and rubber-tipped style plunger. Be sure components are installed in the order shown, and the rubber-tipped plunger is installed in the direction shown. Note that the metal-tipped style plunger shown in Figure 2 may be installed in either direction if the metal plunger separates from the brass holder. The third style, Figure 3, is already assembled as one piece. Be sure to thoroughly clean the sensor and its components, and install the sensor using the new supplied O-ring. Refer to the vehicle service manual for correct tightening specs. Replace a damaged or defective sensor (dealer item). If code P550 is set, be sure to verify proper operation of sensor and the ECM before servicing or replacing the power steering pump.
