CARDONE ProTech

23-1810 Making Clunking Noise? It's Probably Not the Rack

2004-2010 Chevrolet Malibu

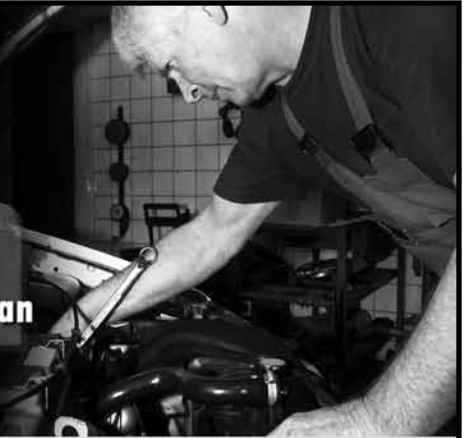
Complaints related to noise, specifically "clunking" during low speed turns.

The manual rack and pinion (23-1810) is part of the Electronic Power Steering System (EPS) for the vehicles listed above. EPS systems provide assist only when needed, so the driver feels when the motor engages/disengages for assist-on/assist-off driving. The different torque characteristic of this system is not typical of a hydraulic system. The noise complaint is most likely due to three possible conditions that are clearly defined in GM TSB 06-02-32-007G, which are:

- Intermediate shaft sticking or slipping
- Interference between the intermediate shaft clamp and steering gear input shaft
- Strut mount or sway bar link condition

In addition to the TSB information, there is also a precise mounting bolt torque specification that must be followed to ensure that the rack is properly mounted to the frame. If this specification is not followed, vibration can also lead to misdiagnosed noise.

- Tighten mounting bolts to **52 ft-lbs. (70Nm) plus an additional 90 degrees.**
