CARDONE ProTech

GM Power Steering Gear Pop or Crunch Noise

GM power steering gears: 27-6535, 6560, 7525, 7547, 7549, 7561, 7562, 7563, 7573 and 7583.

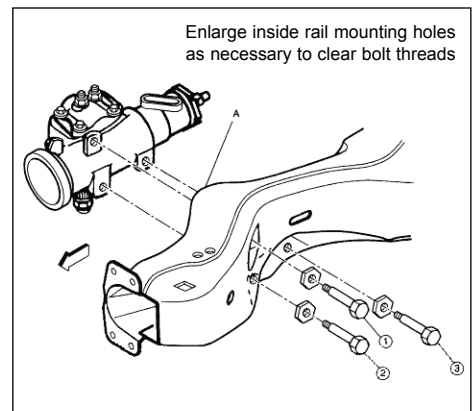
The lower control arm may be striking the steering knuckle during full-turn-type maneuvers, causing the crunch sound. Slight movement between the steering gear attaching bolt threads and the frame rail inboard steering gear attaching holes may cause the popping sound.

Popping sound: Examine the frame rail inboard steering gear attaching holes for evidence of bolt thread contact. Enlarge inboard mounting holes that show contact only enough to allow the bolt threads to be free in the frame holes (use appropriate tools for the job). Reinstall the gear, but do not tighten bolts 1, 2 and 3 (see figure 1). Then perform the following steps:

1. Start the vehicle and cycle the steering lock to lock several times, allowing the gear to reposition itself.
2. Torque attaching bolts (1, 2 and 3) to 70 ft. lbs. (95 Nm).
