CARDONE ProTech

Belt Tensioner May Cause Supercharger Failure

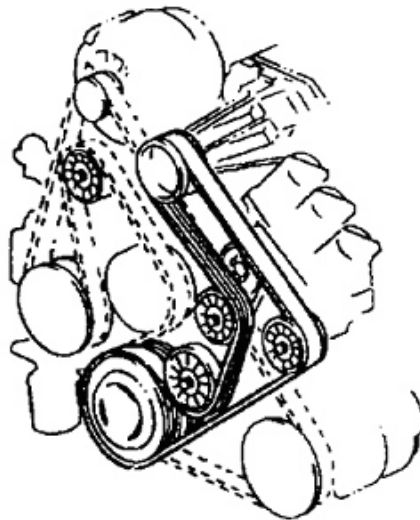
Premature failure of supercharger bearings.

When the belt tensioner starts to fail, belt tension increases dramatically. This tension shows up as side-loading in the supercharger rear bearing.

Periodic inspection of the belt tensioner should be part of the regular maintenance routine. Before operating the replacement supercharger, the tensioner must be inspected and replaced if defective. Unless the tensioner is checked and replaced as needed, supercharger-bearing failure will occur, causing premature catastrophic failure.

While this problem is prevalent on GM vehicles, this inspection should be performed on all belt-driven supercharged vehicles. Please check your vehicle service manual for the recommended inspection and service.
