## OPTIMIZING GM'S OPTI-SPARK DISTRIBUTOR

All GM engines equipped with OPTI-SPARK Distributors  
30-1803, 1832, 1833 (Cap and Rotor supplied)  
30-1803H, 1832H, 1833H (Cap, Rotor and Sealed Harness supplied)

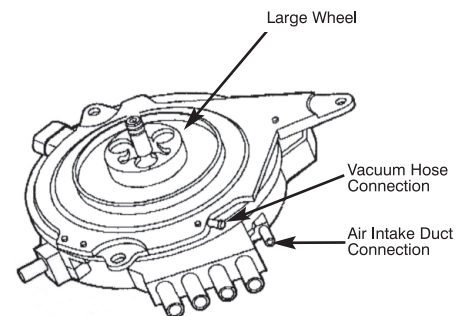
Design 2

Inadequate venting, or closed/inoperative distributor Positive Vent System causing condensation to form. The result is internal corrosion, carbon tracking, housing cracks or sensor failure. A leaking water pump allows coolant to seep into the harness causing connector corrosion resulting in poor electrical connection.

- Verify that units equipped with the Positive Vent System (see design 2 below) do not have lines that are clogged or kinked.
- Check the vacuum source and lines at the intake manifold under the throttle plates for kinks or restrictions.
- Clean debris from housing vents and around distributor housing.
- Use anti-conductive grease when installing connector to prevent corrosion.
- Inspect coolant hoses around distributor for leaks.
- Check connectors for corrosion. Repair or replace vehicle connector as needed.
