CARDONE ProTech

58-551 WATER PUMP PLASTIC IMPELLER FAILURE

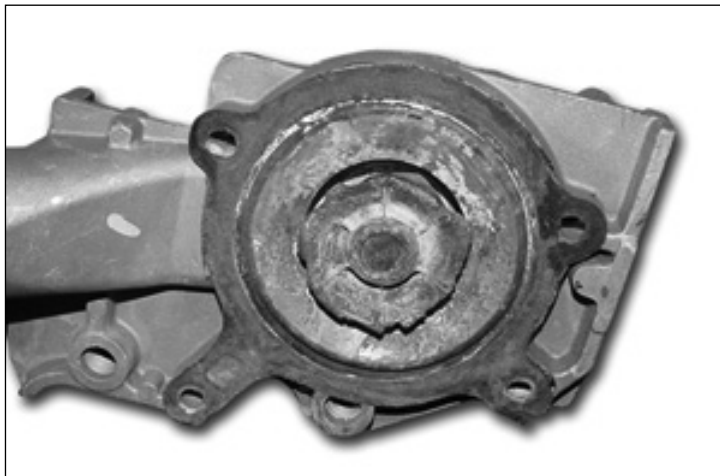
If the original pump impeller looks eroded like the sample picture below, cylinder head or gasket problems will destroy the replacement unit if not corrected.

Plastic impellers erode because of steam in coolant (typical failure shown below). Head gasket leaks and cracked heads allow aeration of the coolant, which develops pockets of super-heated air that destroys the impeller.

Maintain proper coolant levels, eliminate air bubbles, use O.E. recommended coolant, check operation of thermostat, and quickly repair gasket or head problems.
