# CARDONE ProTech

## Recommended Method of Selecting Chrysler Flash Calibrations

All Chrysler vehicles with Flash-technology PCMs.

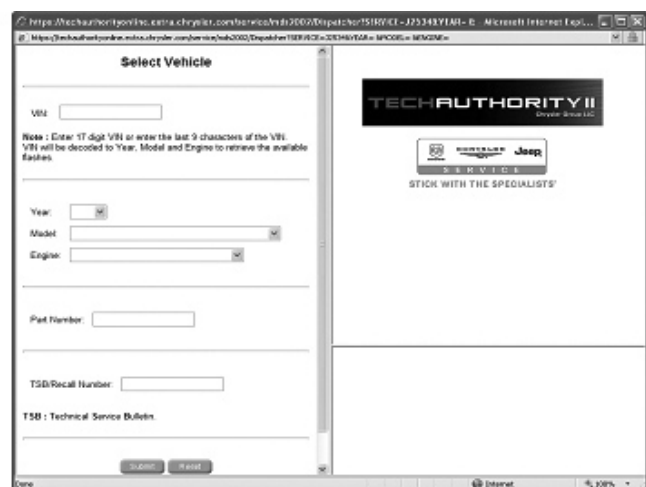
Chrysler's Flash site ([www.techauthority.com](http://www.techauthority.com)) allows four different ways to search for a calibration (also called part number). The screen shot below shows those search options. Unless "Part Number" search is used, multiple calibrations may be listed that could cause the stated problem if the wrong calibration is chosen. Using the "Part Number" option ensures that only those calibrations relating to the original part are selectable. Hence, the random selection problem is avoided.

To use the Part Number method, start by retrieving the part number from the memory of the original PCM. If that is not possible, the number can be obtained from the label on the old unit. It can also be found on the original selling invoice or by contacting Chrysler.
