CARDONE ProTech

2005-06 Ford Escape/Mercury Mariner ECM Problem

78-1044F for 2005-2006 Ford Escape and Mercury Mariner 2WD 3.0L

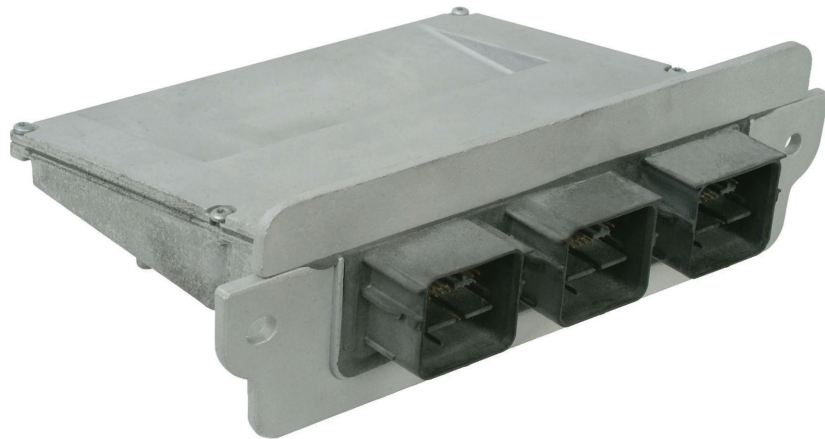
Mis-fire, poor engine performance. Setting fault codes for coil-on-plug (COP) or Powertrain Control Module (PCM). No change in performance after replacing components or repeated failure of replacement components.

Radio Frequency (RF) from spark plugs may cause damage to the COP's and PCM.

Before installing and operating a replacement Powertrain Control Module (PCM), please refer to Ford Technical Service Bulletin (TSB) 10-18-10. Ford warns that radio frequency (RF) interference from the spark plugs may have led to failure of one or more coil-on-plug (COP) ignition coils and the original PCM. All COP ignition coils must be replaced, as specified in the TSB, to prevent damage to the replacement PCM. Replacement COP's are redesigned with additional RF suppression.
