CARDONE ProTech

GM Rack & Pinion Noise Issue

2004-2010 Chevrolet Malibu
2005-2010 Pontiac G6
2005-2008 Saturn Aura

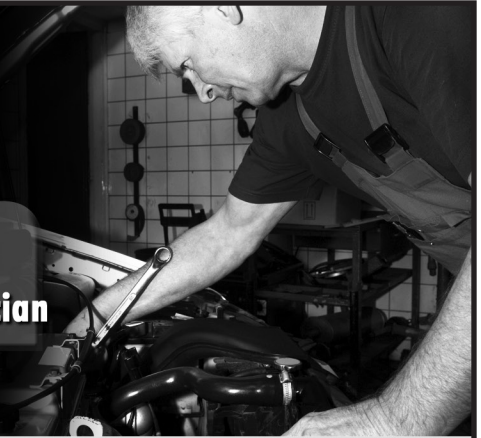
Complaints related to noise, specifically “clunking” during low speed turns.

The manual rack and pinion (23-1810) is part of the Electronic Power Steering System (EPS) for the vehicles listed above. EPS systems provide assist only when needed, so the driver feels when the motor engages/disengages for assist-on/assist-off driving. The different torque characteristic of this system is not typical of a hydraulic system. The noise complaint is most likely due to three possible conditions that are clearly defined in GM TSB 06-02-32-007G, which are:

- Intermediate shaft sticking or slipping
- Interference between the intermediate shaft clamp and steering gear input shaft
- Strut mount or sway bar link condition

In addition to the TSB information, there is also a precise mounting bolt torque specification that must be followed to ensure that the rack is properly mounted to the frame. If this specification is not followed, vibration can also lead to misdiagnosed noise.

- Tighten mounting bolts to **52 ft-lbs. (70Nm) plus an additional 90 degrees.**
