CARDONE ProTech

GM Opti-Spark Distributor Design Solutions

All GM engines equipped with OPTI-SPARK Distributors
30-1803, 1832, 1833 (Cap and Rotor supplied)
30-1803H, 1832H, 1833H (Cap, Rotor and Sealed Harness supplied)

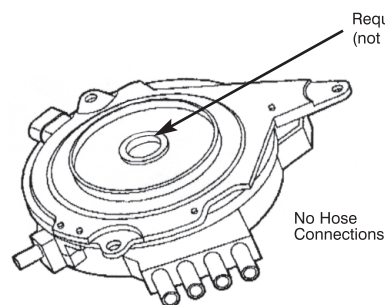
Design 1

(30-1832)

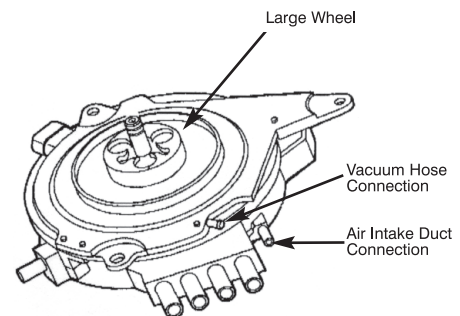
Design 2

(30-1803 & 1833)

- Verify that units equipped with the Positive Vent System (see design 2 below) do not have lines that are clogged or kinked.
- Check the vacuum source and lines at the intake manifold under the throttle plates for kinks or restrictions.
- Clean debris from housing vents and around distributor housing.
- Use anti-conductive grease when installing connector to prevent corrosion.
- Inspect coolant hoses around distributor for leaks.
- Check connectors for corrosion. Repair or replace vehicle connector as needed.
