CARDONE ProTech

GM or Subaru CVs Appear Boxed Wrong — Transfer Stub Shaft

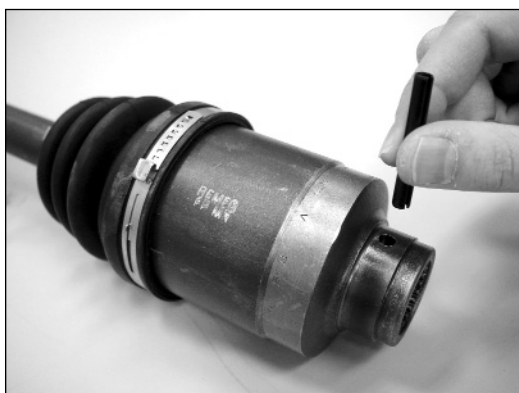
Subaru Design

Inboard housing of original unit is male; the replacement unit is female. Is the replacement unit boxed wrong?

The inboard stub shaft is removable. For axles of this type, the original stub shaft is either stuck in the original unit or is secured with a roll pin.

Transfer the stub shaft to the replacement unit. Some typical units are shown below. CARDONE supplies a new roll pin for units of that design.
