CARDONE ProTech

Tips To Prevent CV Axle From Getting Stuck in Transmission

All Front Wheel Drive Vehicles With CV Axles.

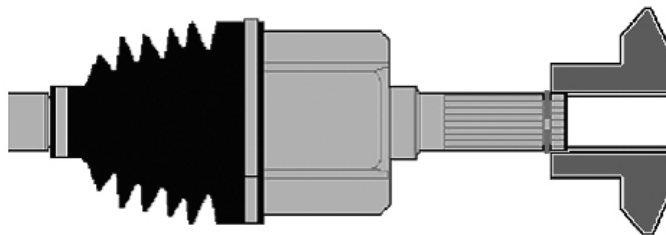
Top View

Inability to remove inner CV axle joint from transmission.

C-clip mis-shaped or rolled over upon installation.

Useful tips before installing axle into transmission:

- Use a small amount of light grease to help slide the splines and clip in.
- Orient the clip opening at 12:00 to prevent the ends from rolling over.
- Use a special compress tool where applicable.
- Do not use a hammer or force the axle into the transmission.
