# CARDONE ProTech

## Overlooked Pressure Hose Seal Causes Power Steering Leaks

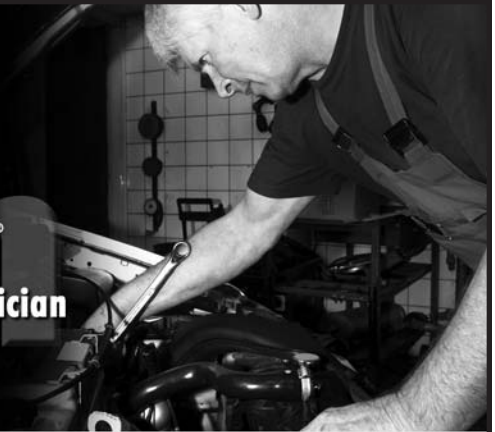
After replacing the Power Steering Pump or steering unit, leaks develop at fittings.

Original O-rings were not replaced, damaged or not properly installed.

Install all supplied O-ring seals as per installation instructions. Be sure to replace the seal inside the pressure hose.

Slide pressure hose fitting back and remove old seal. Soften new seal in warm water, expand over a tapered punch, then transfer to hose as shown.
