CARDONE ProTech

Overlooked Pressure Hose Seal Causes Power Steering Leaks

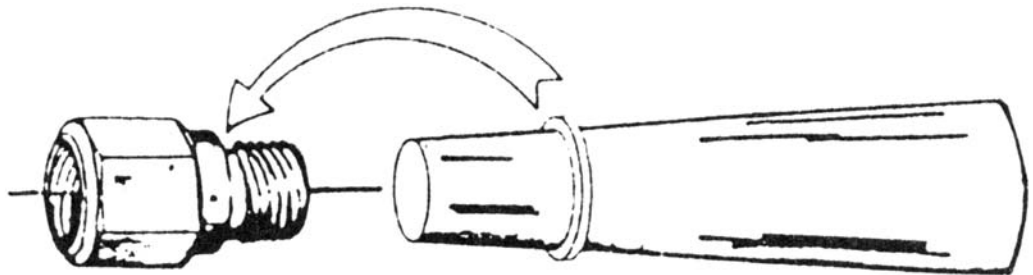
Slide pressure hose fitting back and remove old seal. Soften new seal in warm water, expand over a tapered punch, then transfer to hose as shown.

Install all supplied O-ring seals as per installation instructions. Be sure to replace the seal inside the pressure hose.
