CARDONE ProTech

Excessive Rotation of Steering Causes Air Bag Coil Damage

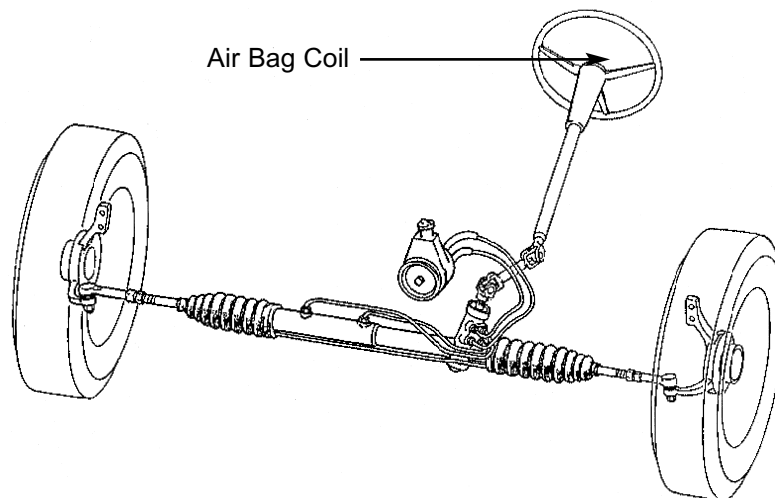
The steering wheel **must** be held in the center position prior to removal of intermediate steering shaft (use appropriate tool). This will prevent excessive rotation of the steering column and failure of the air bag coil.
