CARDONE ProTech

Operating Wiper Motor Before Installation Causes Problems

Application: All Electric Wiper Motors.

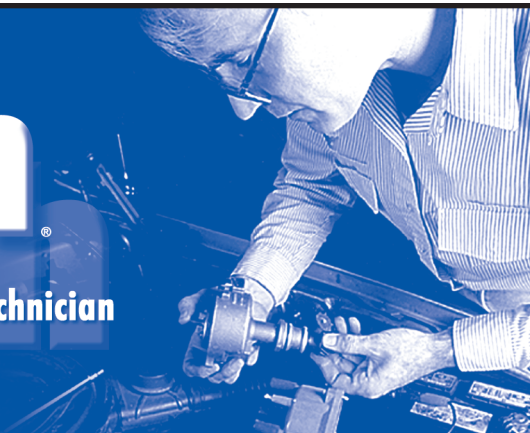
Problem: Replacement wiper motor parks in wrong position.

Cause: Power was applied to the unit before installation moving it off park position.

Solution: Remove linkage from installed unit, operate motor on high speed for 5 seconds, then switch to park position. Reinstall linkage so wiper arms are in park position. Operate unit and test for proper operation. If not correct, test motor ground (see Pro Tech PT 40-0001), also refer to vehicle service manual for specific installation procedures.

Note: CARDONE units are supplied in the correct park position.
