CARDONE ProTech

Failed Booster Seal Causes Master Cylinder Leaks

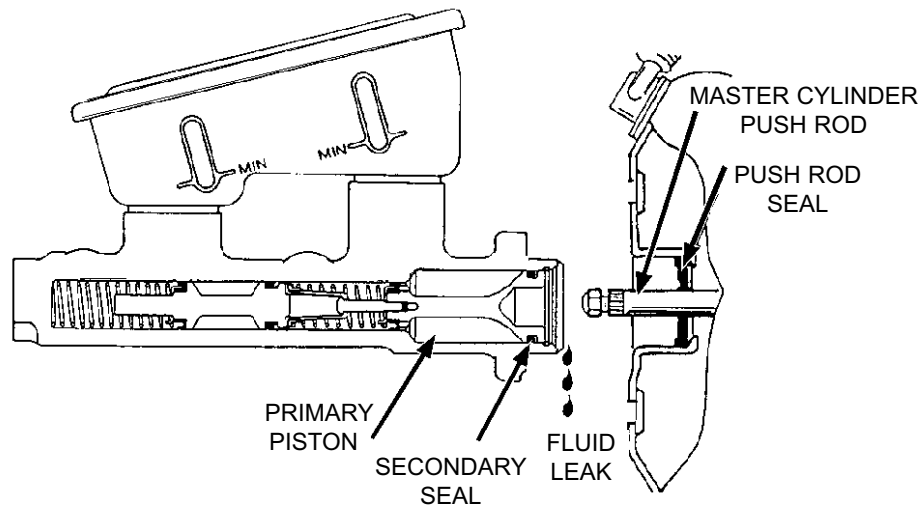
Chronic master cylinder failure due to fluid leaking past secondary seal in the master cylinder bore.

A defective master cylinder pushrod seal in the power brake booster allowing vacuum to draw fluid past secondary seal of the master cylinder.

Replace both master cylinder and power brake unit.

When replacing brake components, always flush entire brake system with approved brake fluid from a sealed container.
