# CARDONE ProTech

## Improper Placement of Fitting O-ring Results in No Pressure

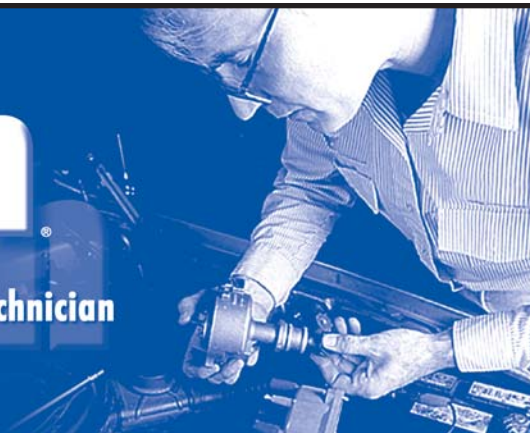
No pressure output from power steering pump after installation of a new O-ring on the power steering pressure fitting.

Incorrect placement of O-ring on the pressure fitting, blocking the flow of fluid from the bypass hole to the flow control valve. This causes a no-pressure condition.

Install the replacement O-ring in the correct position on the fitting. Also make sure piston is moving freely in bore, a stuck piston will cause the same problem.
