CARDONE ProTech

Tips To Prevent CV Axle From Getting Stuck in Transmission

All Front Wheel Drive Vehicles With CV Axles.

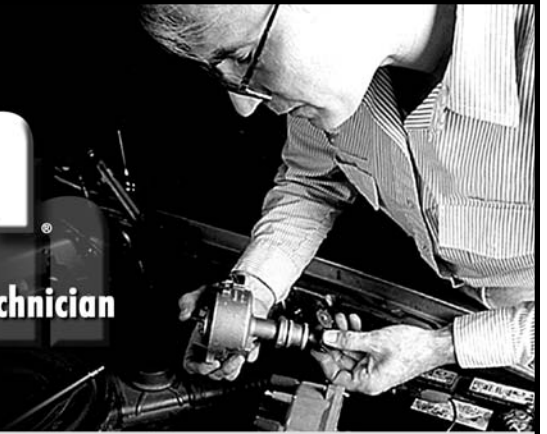
Inability to remove inner CV axle joint from transmission.

C-clip mis-shaped or rolled over upon installation.

Useful tips before installing axle into transmission:

- Use a small amount of light grease to help slide the splines and clip in.
- Orient the clip opening at 12:00 to prevent the ends from rolling over.
- Use a special compress tool where applicable.
- Do not use a hammer or force the axle into the transmission.
