CARDONE ProTech

Chrysler Drivetrain Alignment Prevents CV Pop-Out

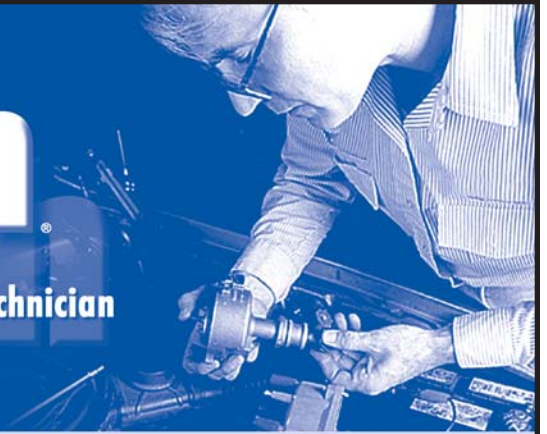
Equal length axles: With the vehicle on the ground, measure the distance from the small boot clamp on the outer joint to the large boot clamp on the inner joint. If unequal, loosen the engine/trans mount bolts and adjust the drivetrain until both measurements are equal.

Different length axles: Remove the nuts from both axles. Push axle towards the transmission and bottom out the inner joint. Measure the distance the stub shaft has moved into the hub. Repeat for the other shaft and compare the measurements. If unequal, loosen the engine/trans mount bolts and adjust the drivetrain until both measurements are equal.
