# CARDONE ProTech

## Don't Let the Power Steering Snake Bite You

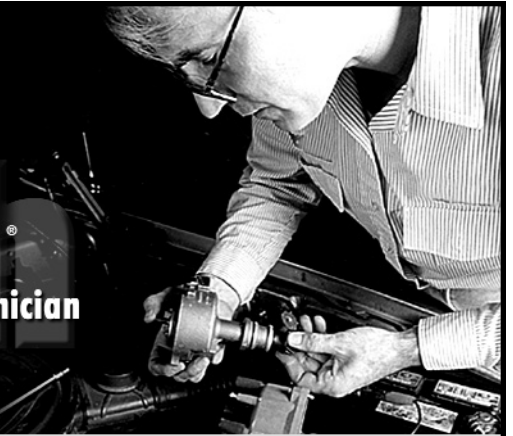
**Problem:** Power steering component failure ( i.e., Rack & Pinion, Gear Box, Pump, Control Valve or Power Cylinder).

**Cause:** Contamination in the steering system.

**Solution:** During installation of the replacement unit carefully inspect the hydraulic hoses. Hoses that appear harmless may have hidden problems. They deteriorate from the inside out, passing contamination throughout the entire system. This results in premature failure of the steering system. ALWAYS FLUSH THE ENTIRE SYSTEM AND REPLACE HOSES TO PREVENT WARRANTY PROBLEMS.

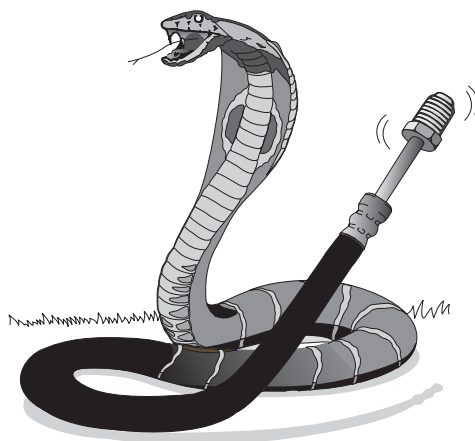
**FAILURE TO REPLACE  
HOSES COULD COME  
BACK TO BITE YOU!**
