CARDONE ProTech

What is Variable Assisted Power Steering, What is EVO?

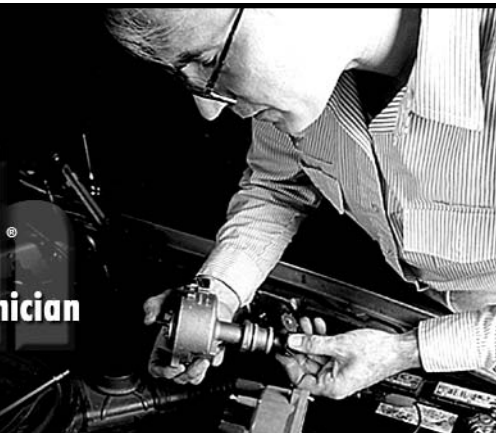
Pump-mounted
Ford EVO
valve

Pump-mounted GM
EVO valve and
adapter
