CARDONE ProTech

Transfer Case Motor Typical Failures and Prevention

Chevy/GMC, Ford, Mazda and Isuzu 4-wheel drive vehicles equipped with Transfer Case Motors.

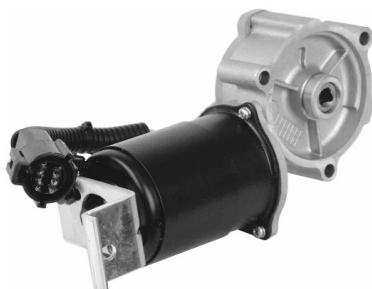
Ford applications require transfer of wire connector pins. Be sure to record pin location before removing the original unit.

Typical Ford Motor

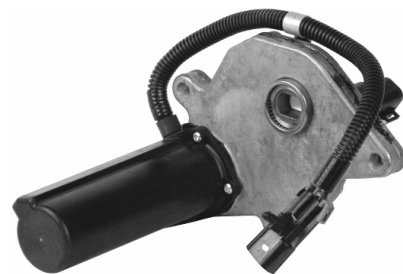
Replacement motors for GM vehicles are supplied in 2-wheel drive position. If necessary, select or move transfer case into 2-wheel drive before installation of replacement motor. GM applications will require a scan tool to clear the codes from the transmission control module (refer to the vehicle service manual for correct tool and procedures).

Typical GM Motor
