CARDONE ProTech

Protecting GM Wiper Motors from Water Intrusion

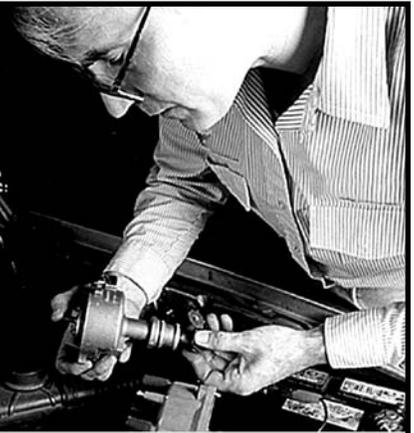
Wiper motors with and without integrated electronic pulse board not working properly or at all.

Wiper motor and/or electronic components may have failed due to water intrusion.

To protect the replacement wiper motor and pulse board, be sure water does not drain on wiper motor assembly. Remove any debris that might block or restrict the flow of drain water to the left or right fender well areas. Be sure to also check for proper operation of control switch and associated wiring.

To prevent water intrusion, our replacement units are re-engineered to overcome original design flaws. Vent holes that allow water entry are blocked, therefore protecting the motor & its electronic components.
